June 25, 2008

Japan Agency for Marine-Earth Science and Technology

The Deep-sea Drilling Vessel CHIKYU Projected measures for the damages on Azimuth Thruster and future schedule

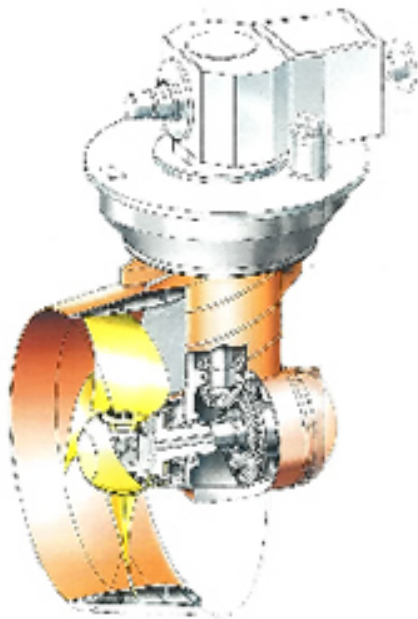
- The vertical shaft (pinion) gear teeth might contact and induce cracks in the wheel gear teeth

- Lack of strength in the internal shear stress or existing impurities in the gear may have caused the cracks.

Figure1: Identified damage is shown in the red squared part in the bevel gear (gear used when it turn right angle).

- Modify the shape and round off the corners of the pinion gear's teeth to avoid contact with the wheel gear.
- Assemble and adjust gear teeth carefully.
- Modify the design to decrease internal shear stress of the gear and enhance internal strength.
- Advance methods to increase carburizing depth
- Improve the quality of gear material to avoid the inclusion of impurities.

Therefore, all six existing gears will be replaced by new ones with the new modified design.

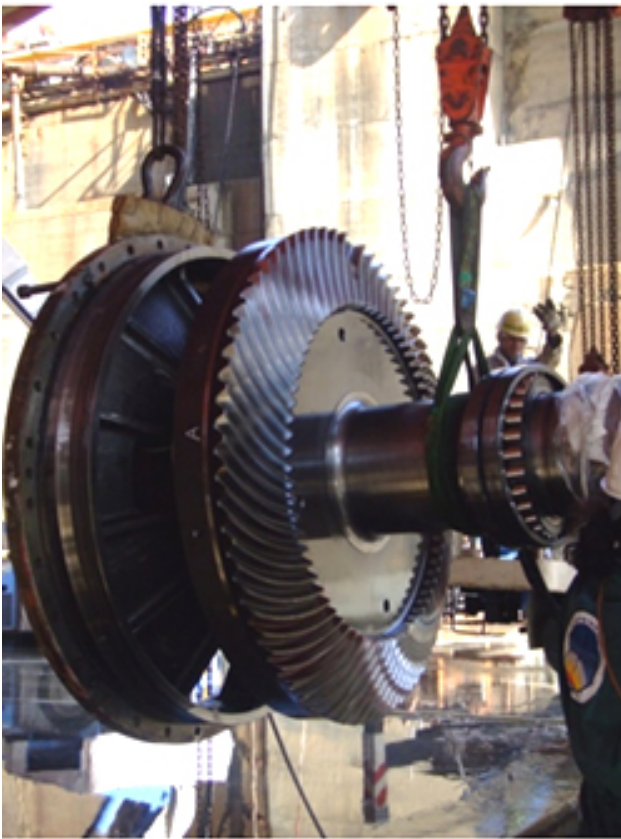
Picture 1: Wheel gear

Damage has been identified on 3 out of 6 wheel gears and one of those was replaced (Picture 1 and 2). It was the first overhaul inspection of Azimuth thruster since the CHIKYU's delivery in July 2005.

Material of gears on the CHIKYU is nickel-chrome molybdenum forged steel treated with carburizing and case-hardening.
